INSPECTION REPORT

For the Property at:
1145 KRYPTON DR.
NEW BERLIN, WI

Prepared for: CLARK KENT and LOIS LANE
Inspection Date: Friday, June 5, 2009
Prepared by: Rob Fischer

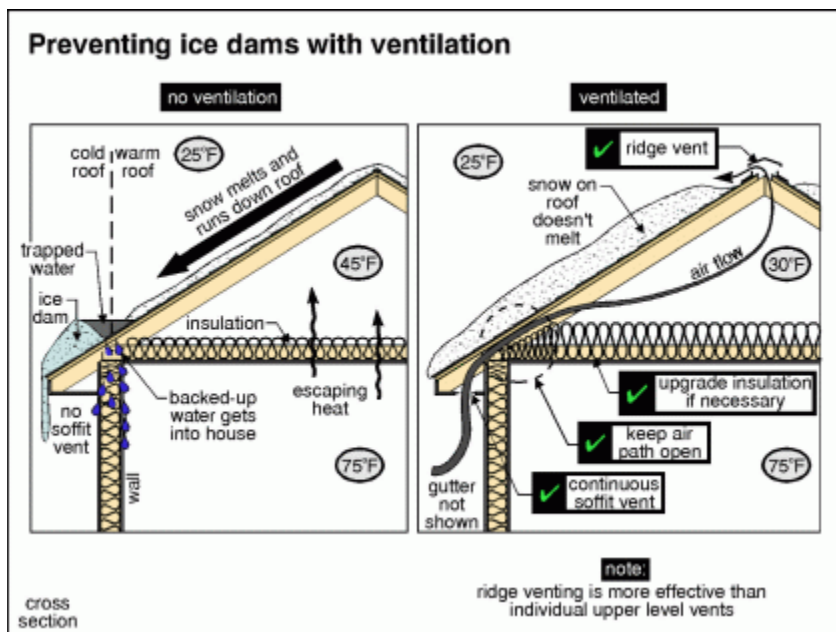
Condition: • [Vulnerable to ice damming](#)

Implication(s): Chance of water damage to contents, finishes and/or structure

Location: Throughout Exterior

Task: Monitor

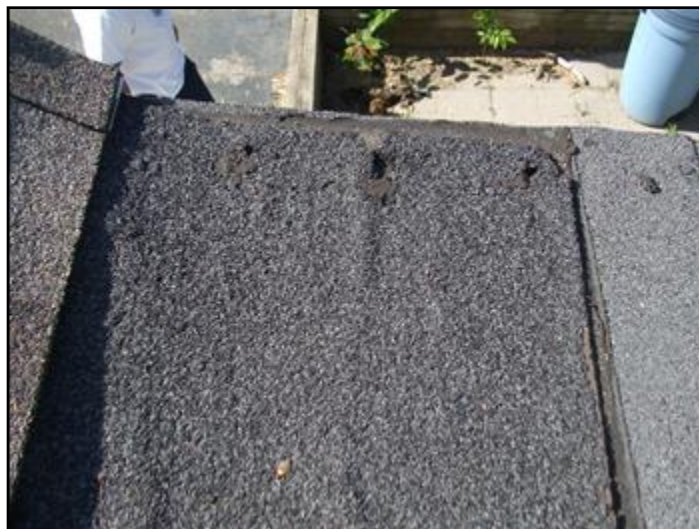
1.

Condition: • [Near end of life expectancy](#)

Implication(s): Chance of water damage to contents, finishes and/or structure

Location: West Exterior

Note: Additional Conditions:

Granule loss

Rusted nails

Exposed nails not sealed

Task: Monitor

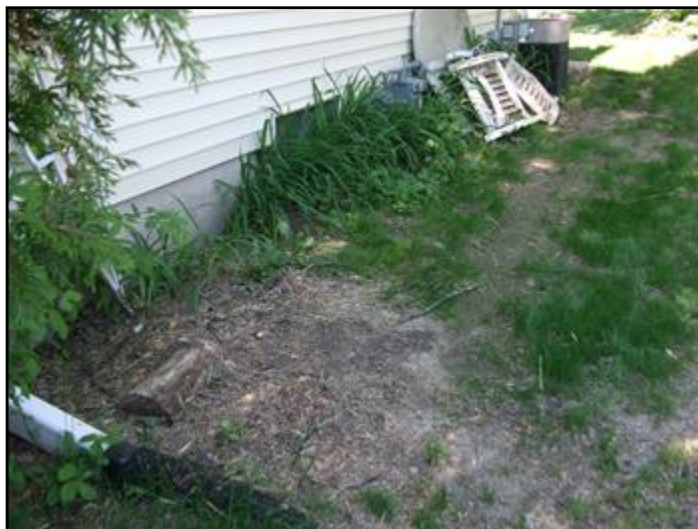
18.

Condition: • Additional backfill required to slope grading away from home to control water and help avoid water/soil pressure on foundation. Proper slope away from house is 1" per foot for approximately 5-6 feet

Location: North Exterior Wall

Task: Provide

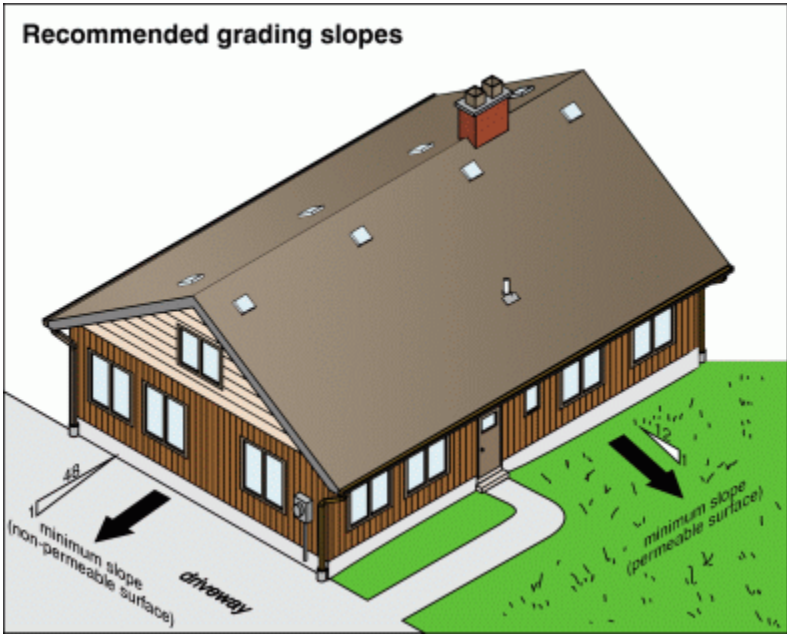
Condition: • Window wells and or Covers are recommended; The amount of water which enters a window well from falling rain is generally slight, but water will accumulate in window wells if yard is improperly graded. Plastic window well covers are useful in keeping out leaves and debris.

Condition: • [Improper slope](#)

Implication(s): Chance of water damage to contents, finishes and/or structure

Location: North Exterior Wall

Task: Improve

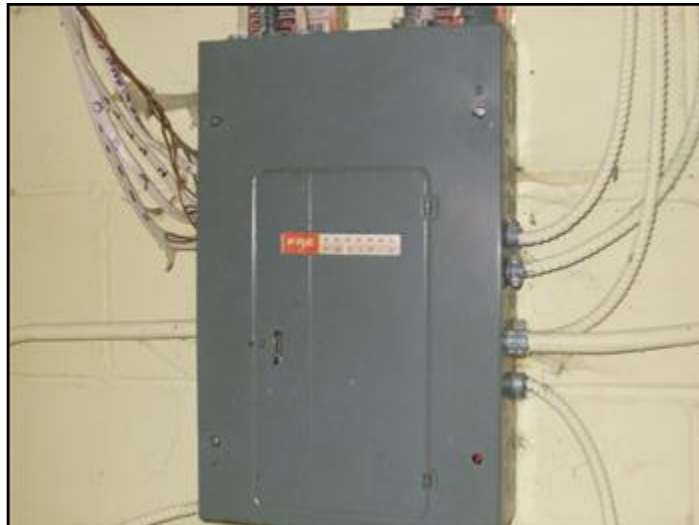
34.

Condition: • [Due to the potential safety hazard with Federal Pacific breakers it is recommended that following system\(s\) be further evaluated and addressed as needed by a Licensed Electrician.](#)

Location: Basement

Task: Further evaluation

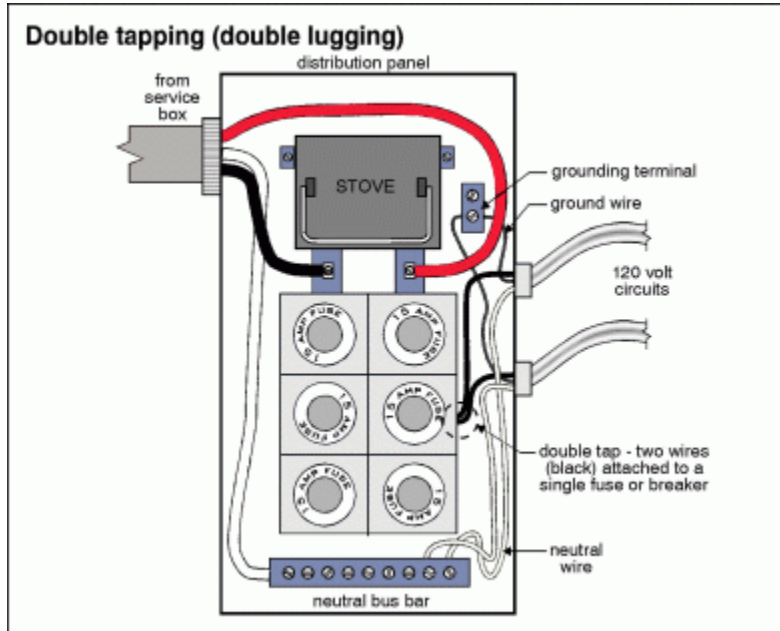
Condition: • [Double taps](#)

Implication(s): Fire hazard

Location: Basement

Task: Repair

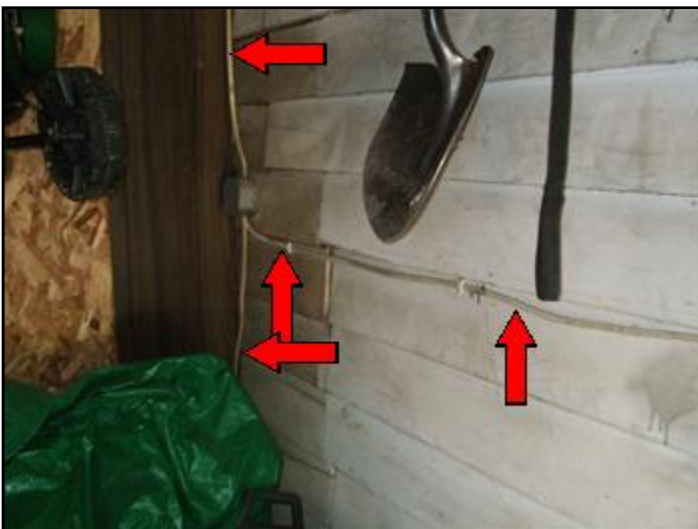
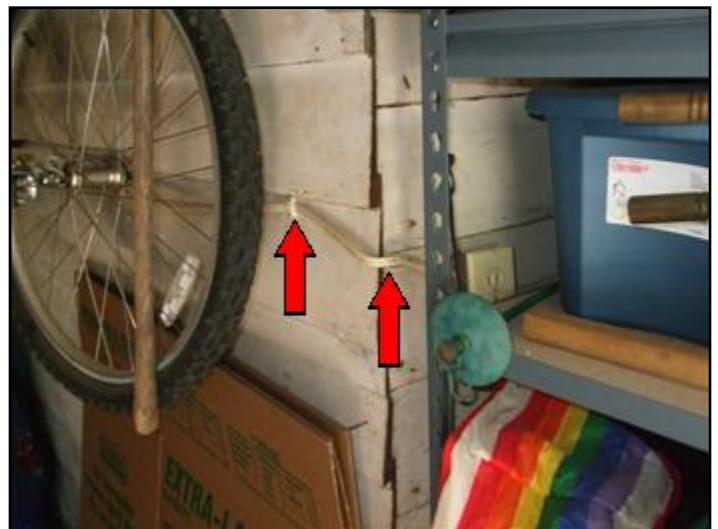
Condition: • Improper installation, loose or drooping wiring. We recommend following NEC installation requirements.

Location: Garage

Task: Repair in near future

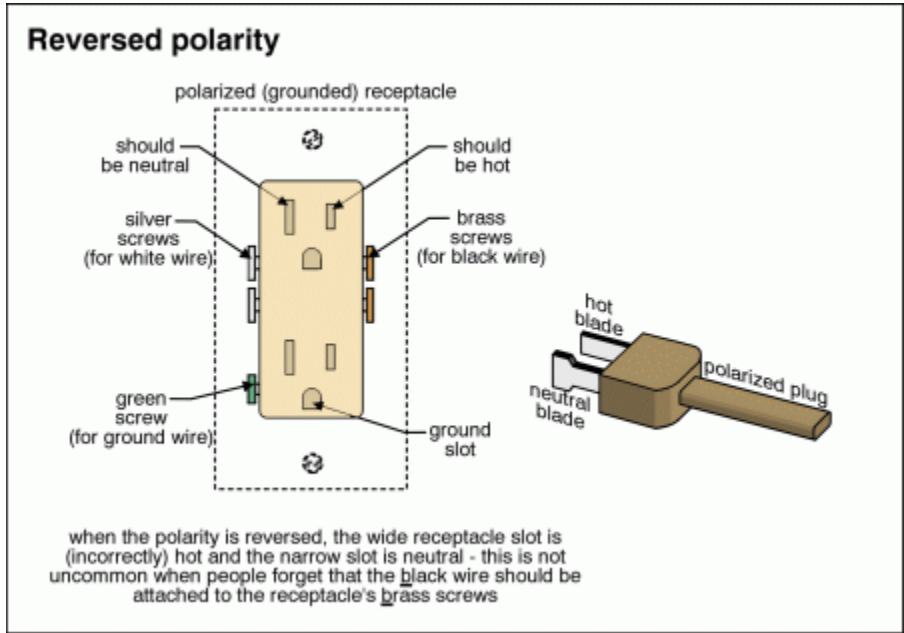
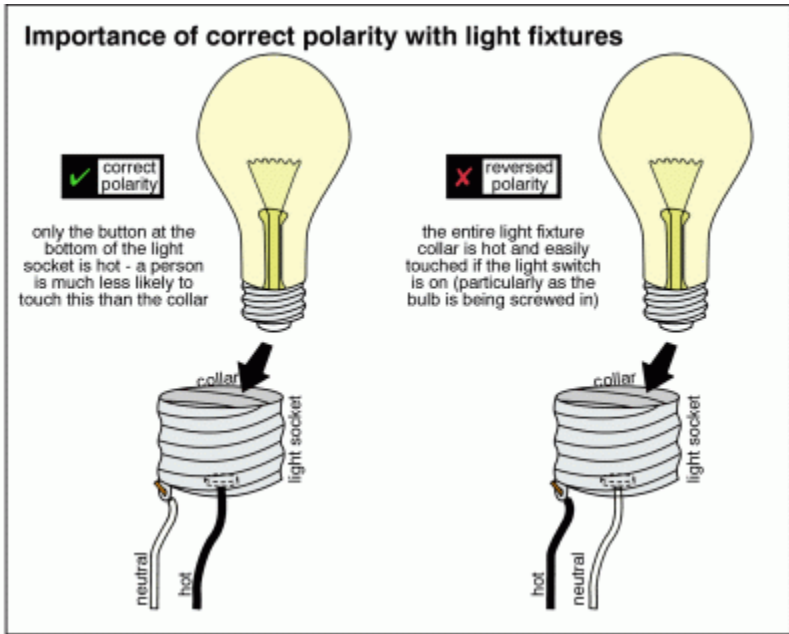
Condition: • [Reversed polarity](#)

Implication(s): Electric shock

Location: First Floor Kitchen

Task: Repair

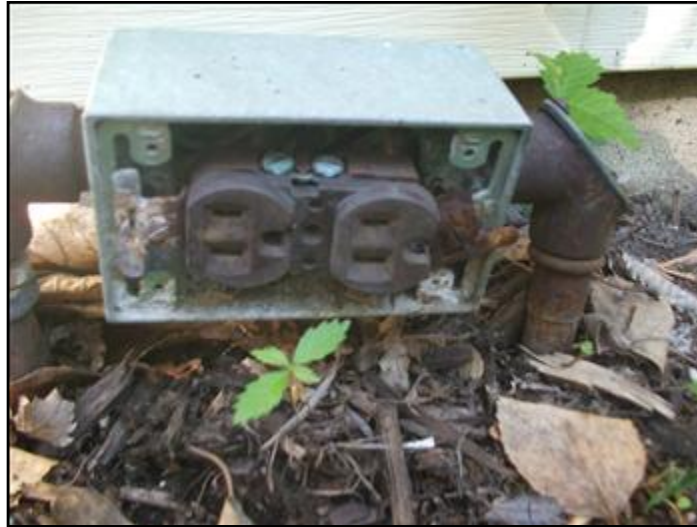
37.

Condition: • No Water Sealed Outside Cover

Location: Front Exterior Wall

Task: Repair

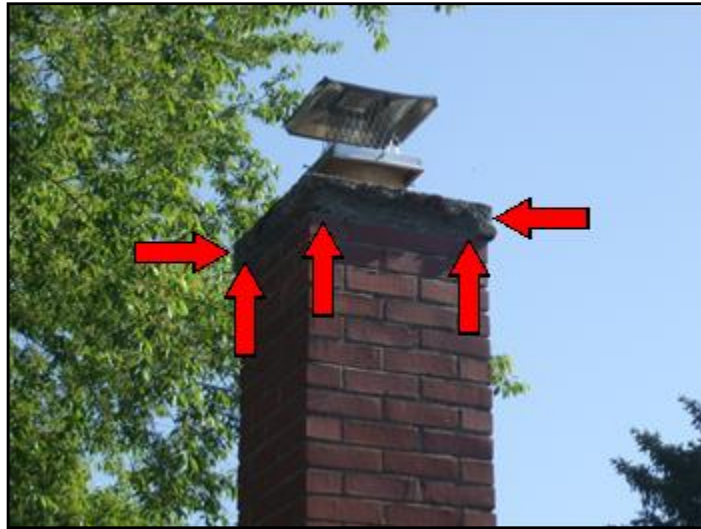
44.

• Deteriorated Masonry Chimney. We recommend a licensed chimney contractor evaluate and make necessary repairs.

Condition: • [Spalling](#)

Implication(s): Chance of water damage to contents, finishes and/or structure | Shortened life expectancy of material

Task: Further evaluation

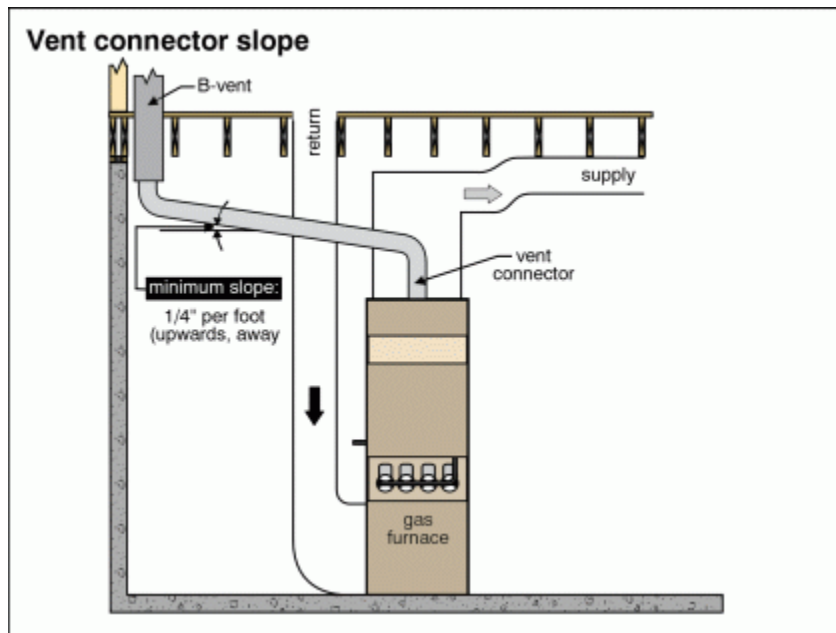
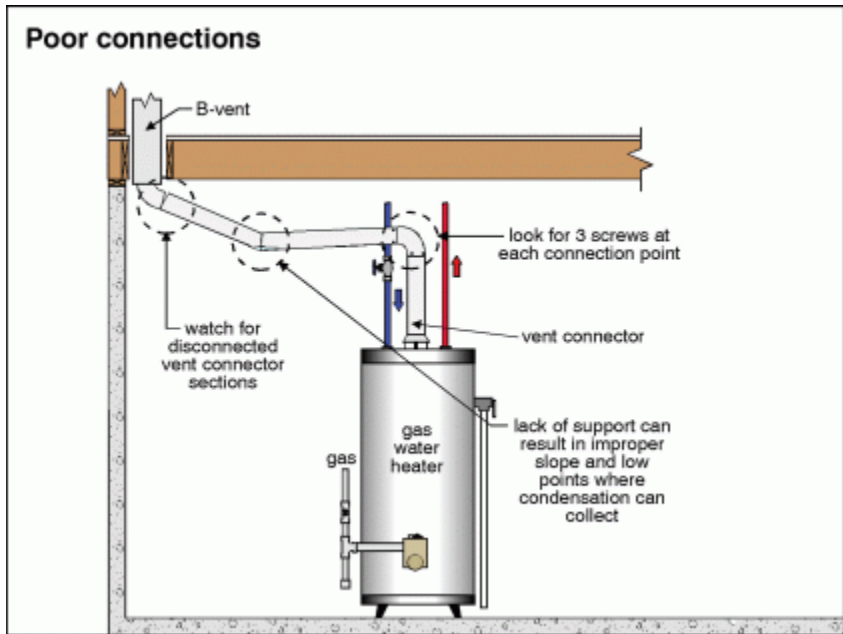
Condition: • [Poor slope](#)

Implication(s): Equipment not operating properly | Hazardous combustion products entering home

Task: Repair

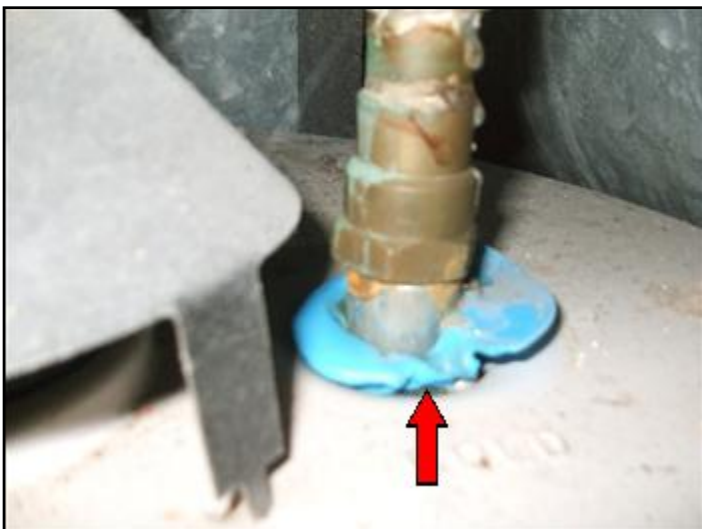
60. Carbon Monoxide/Heat spill over melted plastic

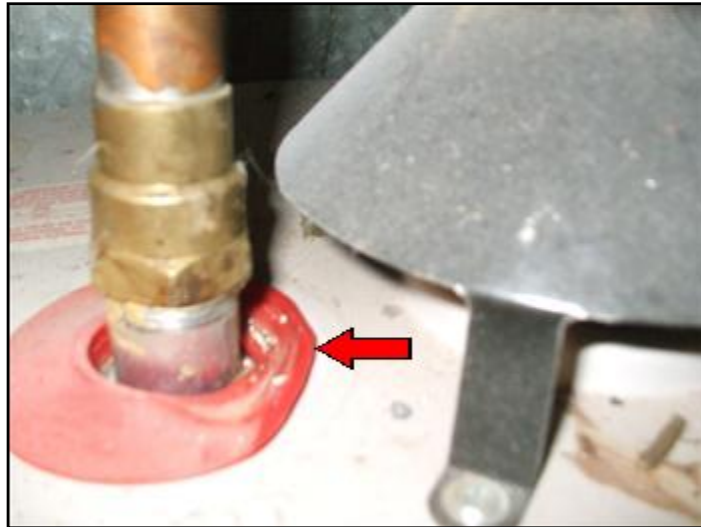
62. Carbon Monoxide/Heat spill over melted plastic
