INSPECTION REPORT

For the Property at:
1145 KRYPTON DR.
NEW BERLIN, WI

Prepared for: CLARK KENT and LOIS LANE
Inspection Date: Friday, June 5, 2009
Prepared by: Rob Fischer

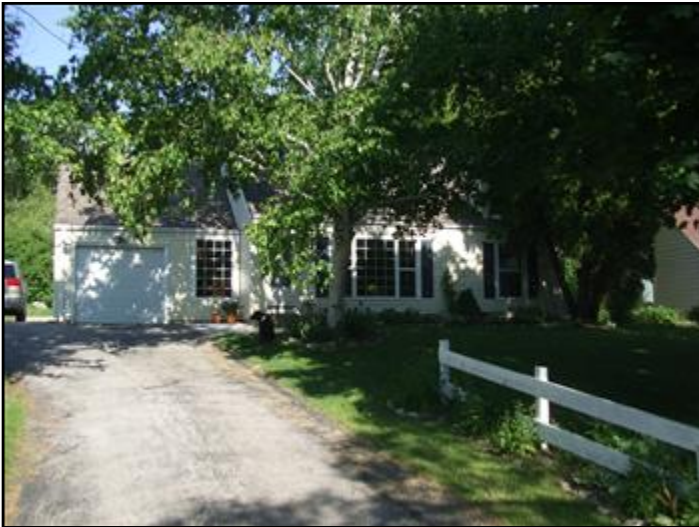
2.

• [Vinyl siding](#)

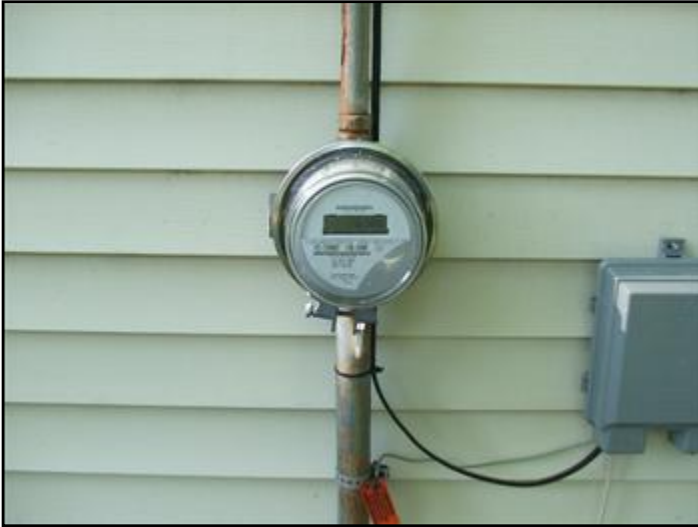
31.

- [Overhead copper](#)

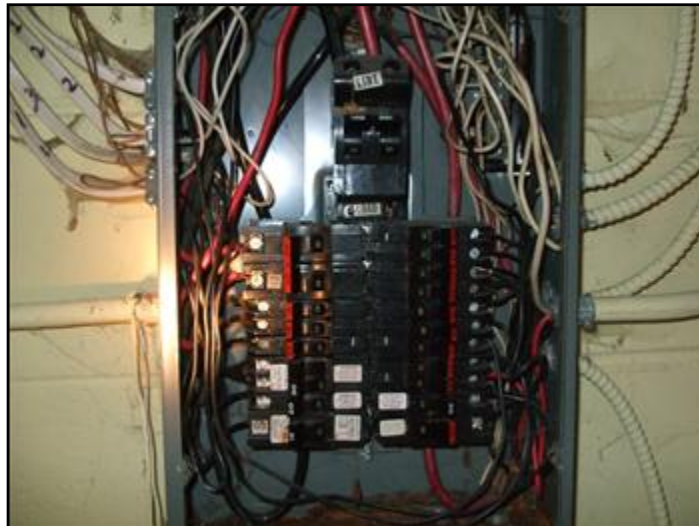
33.

- [100 Amps](#)

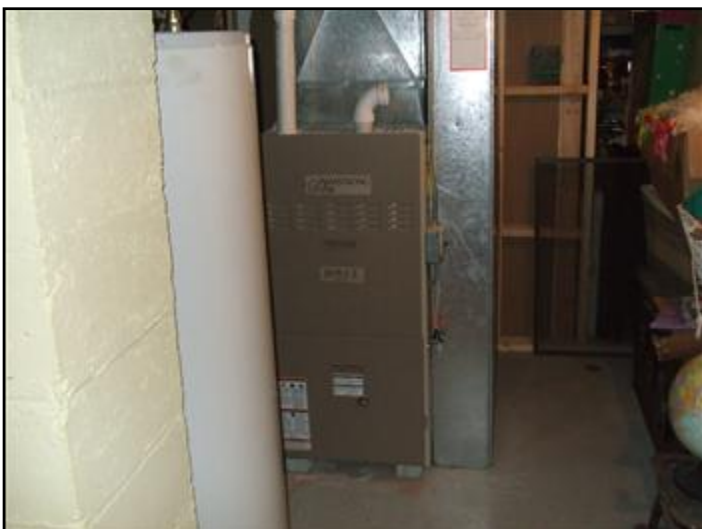
38.

• [Furnace](#)

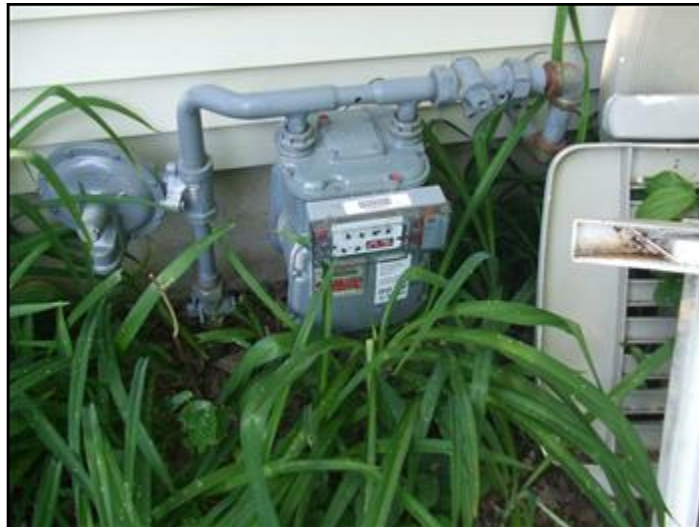
42.

- Meter

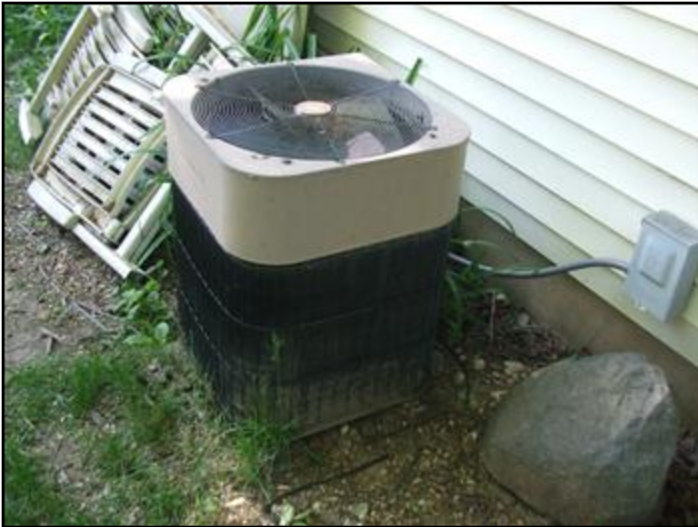
45.

• [Air cooled](#)

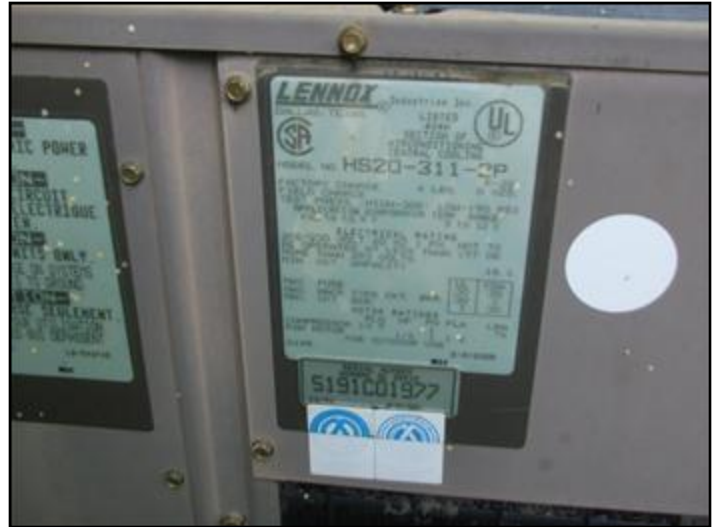
46.

Air conditioning type: • 30 amps Max Breaker/Fuse • Normal operating controls observed • Operated by thermostat.
• A/C Condition: Marginal.

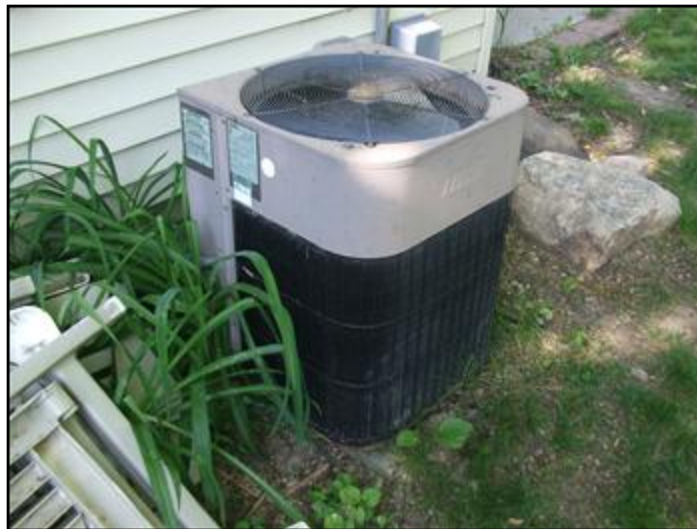
47.

Compressor approximate age: • 18 years

Failure probability: • [High](#)

Condition: • [Old](#)

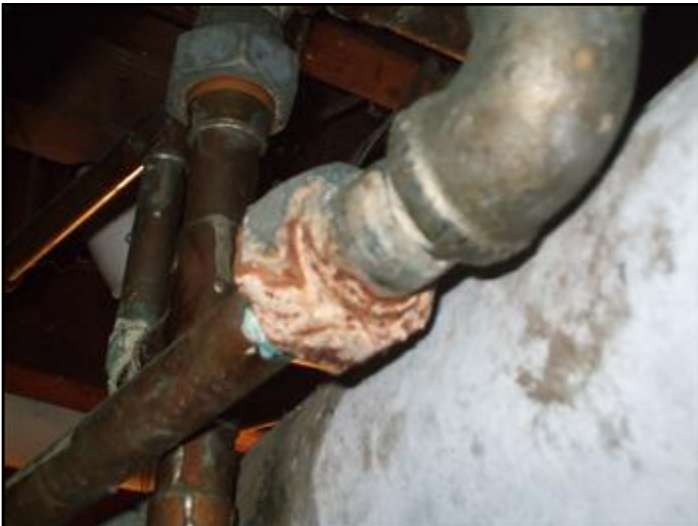
53.

Supply piping in house: • Corroded pipes present

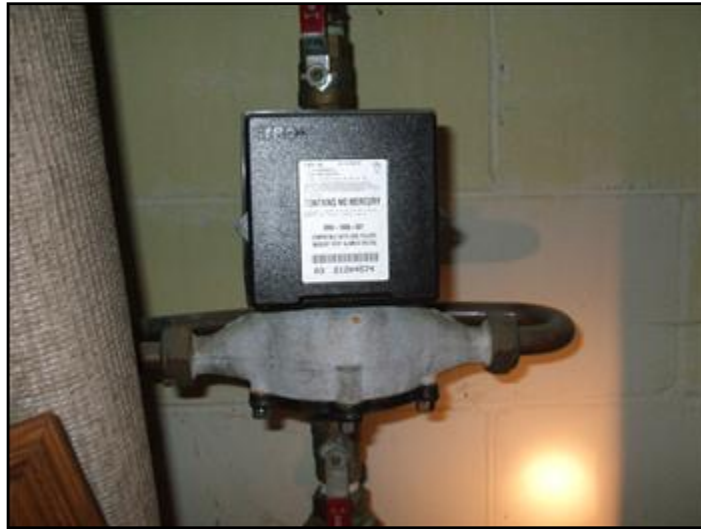
55.

- Front of the basement
- Meter
